File: 20454

**LAC ST ANNE COUNTY ADMINISTRATION BUILDING
SLAB HEAVING CONCERNS**

This letter report presents the results of a supplementary geotechnical investigation carried out by Thurber Engineering Ltd. (Thurber) to assess the floor slab heaving issues that have been noted at the Lac Ste. Anne County Administration Building, in Sangudo, Alberta

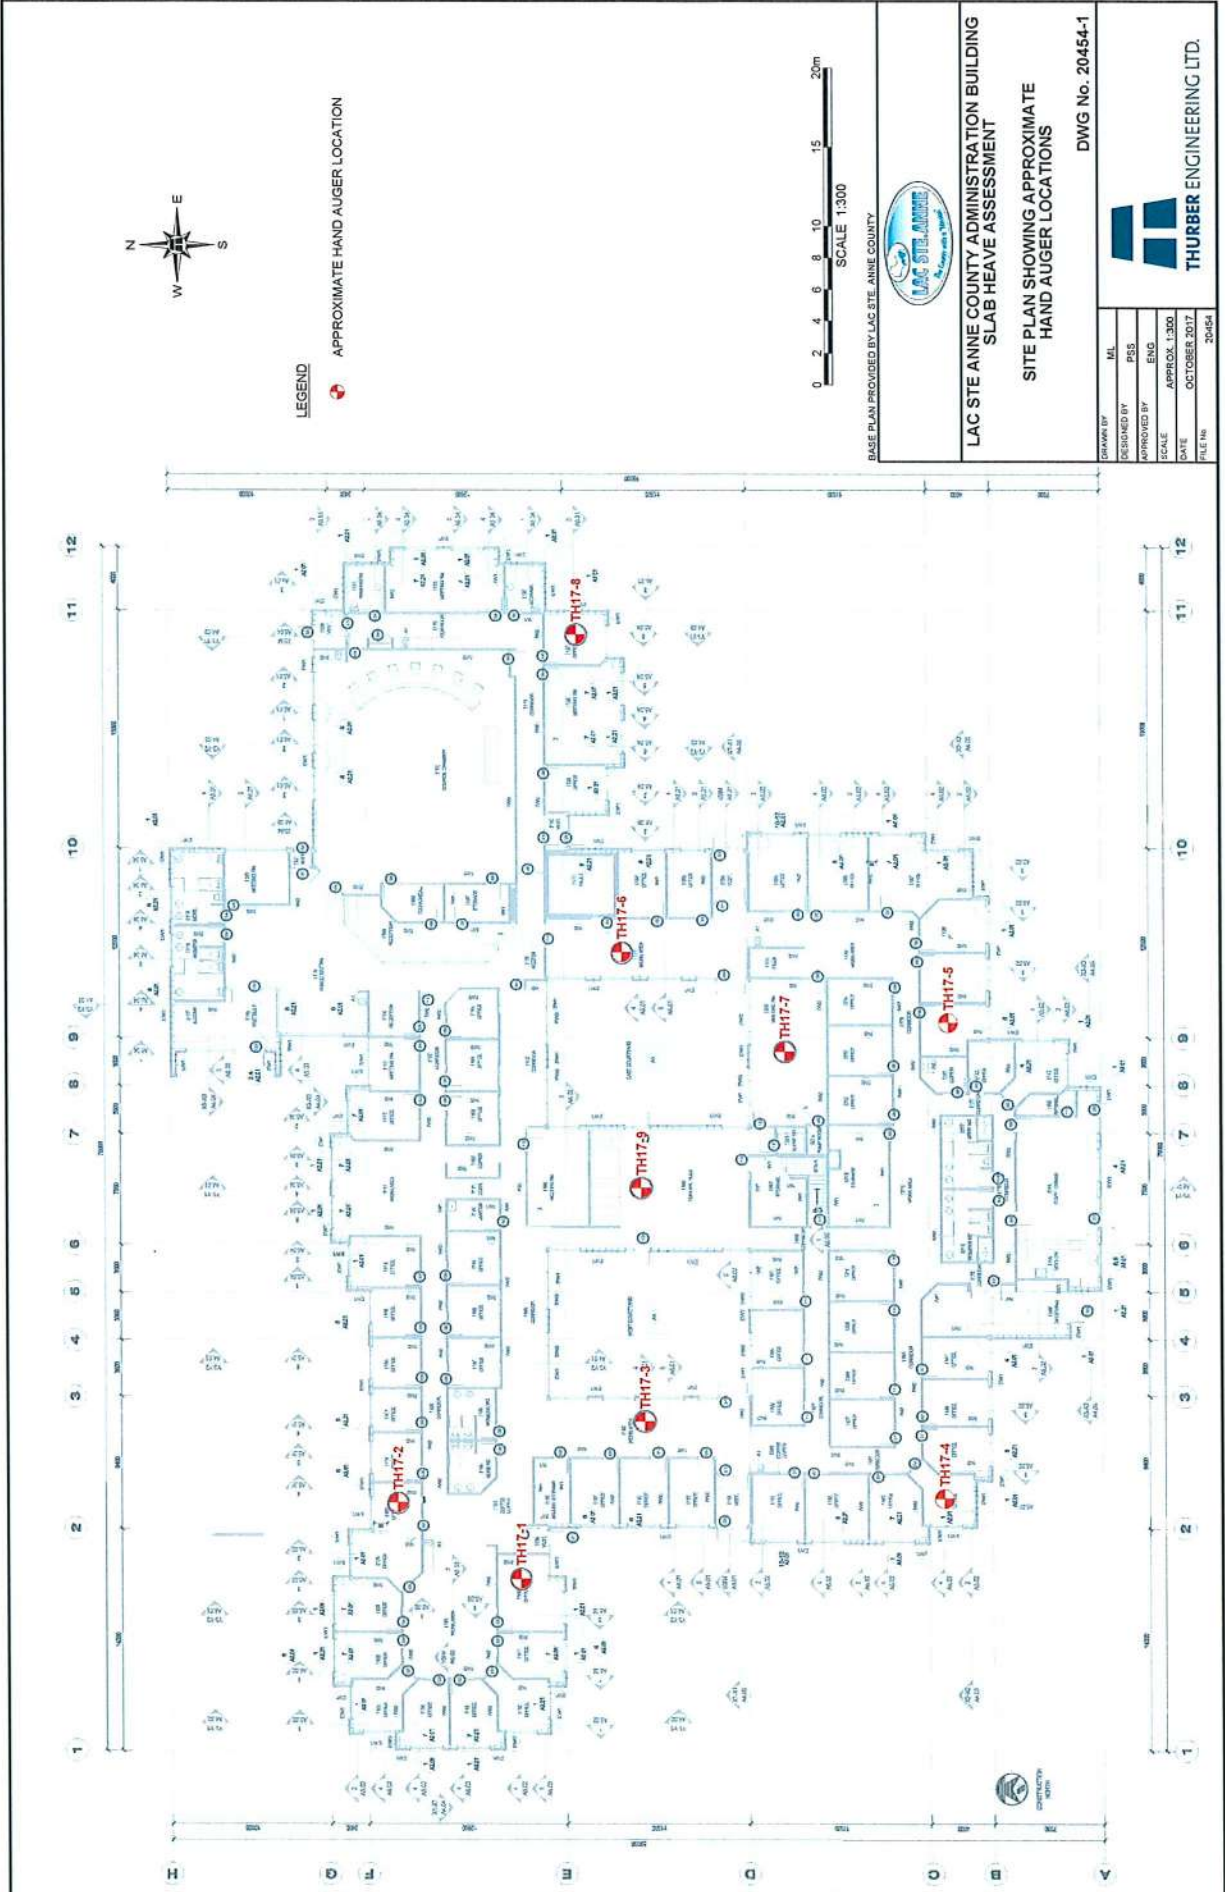
DWG No. 20454-1

Nine (9) hand auger test holes (TH17-1 to TH17-9) were drilled on September 21 and 22, 2017 at the locations shown on the Drawing No. 20454-1 Appendix A. The test holes locations were chosen by LSA personnel and were considered representative of the main areas where floor slab heave has been noted.

1. The gravel base course layer was noted to be dry in all bore holes and no ponding of water was noted on top of the underlying clay layer;
2. Minor groundwater seepage was noted coming in from the underlying clay in several test holes, at depths ranging from 0.5 m (TH17-6) to 1.4 m in TH17-1. Shallow seepage (i.e. around 0.5 to 0.75 m below top of slab) was encountered in TH17-3, 17-6, 17-8 and 17-9. Three of these test holes were located near to the interior courtyards (see attached site plan).

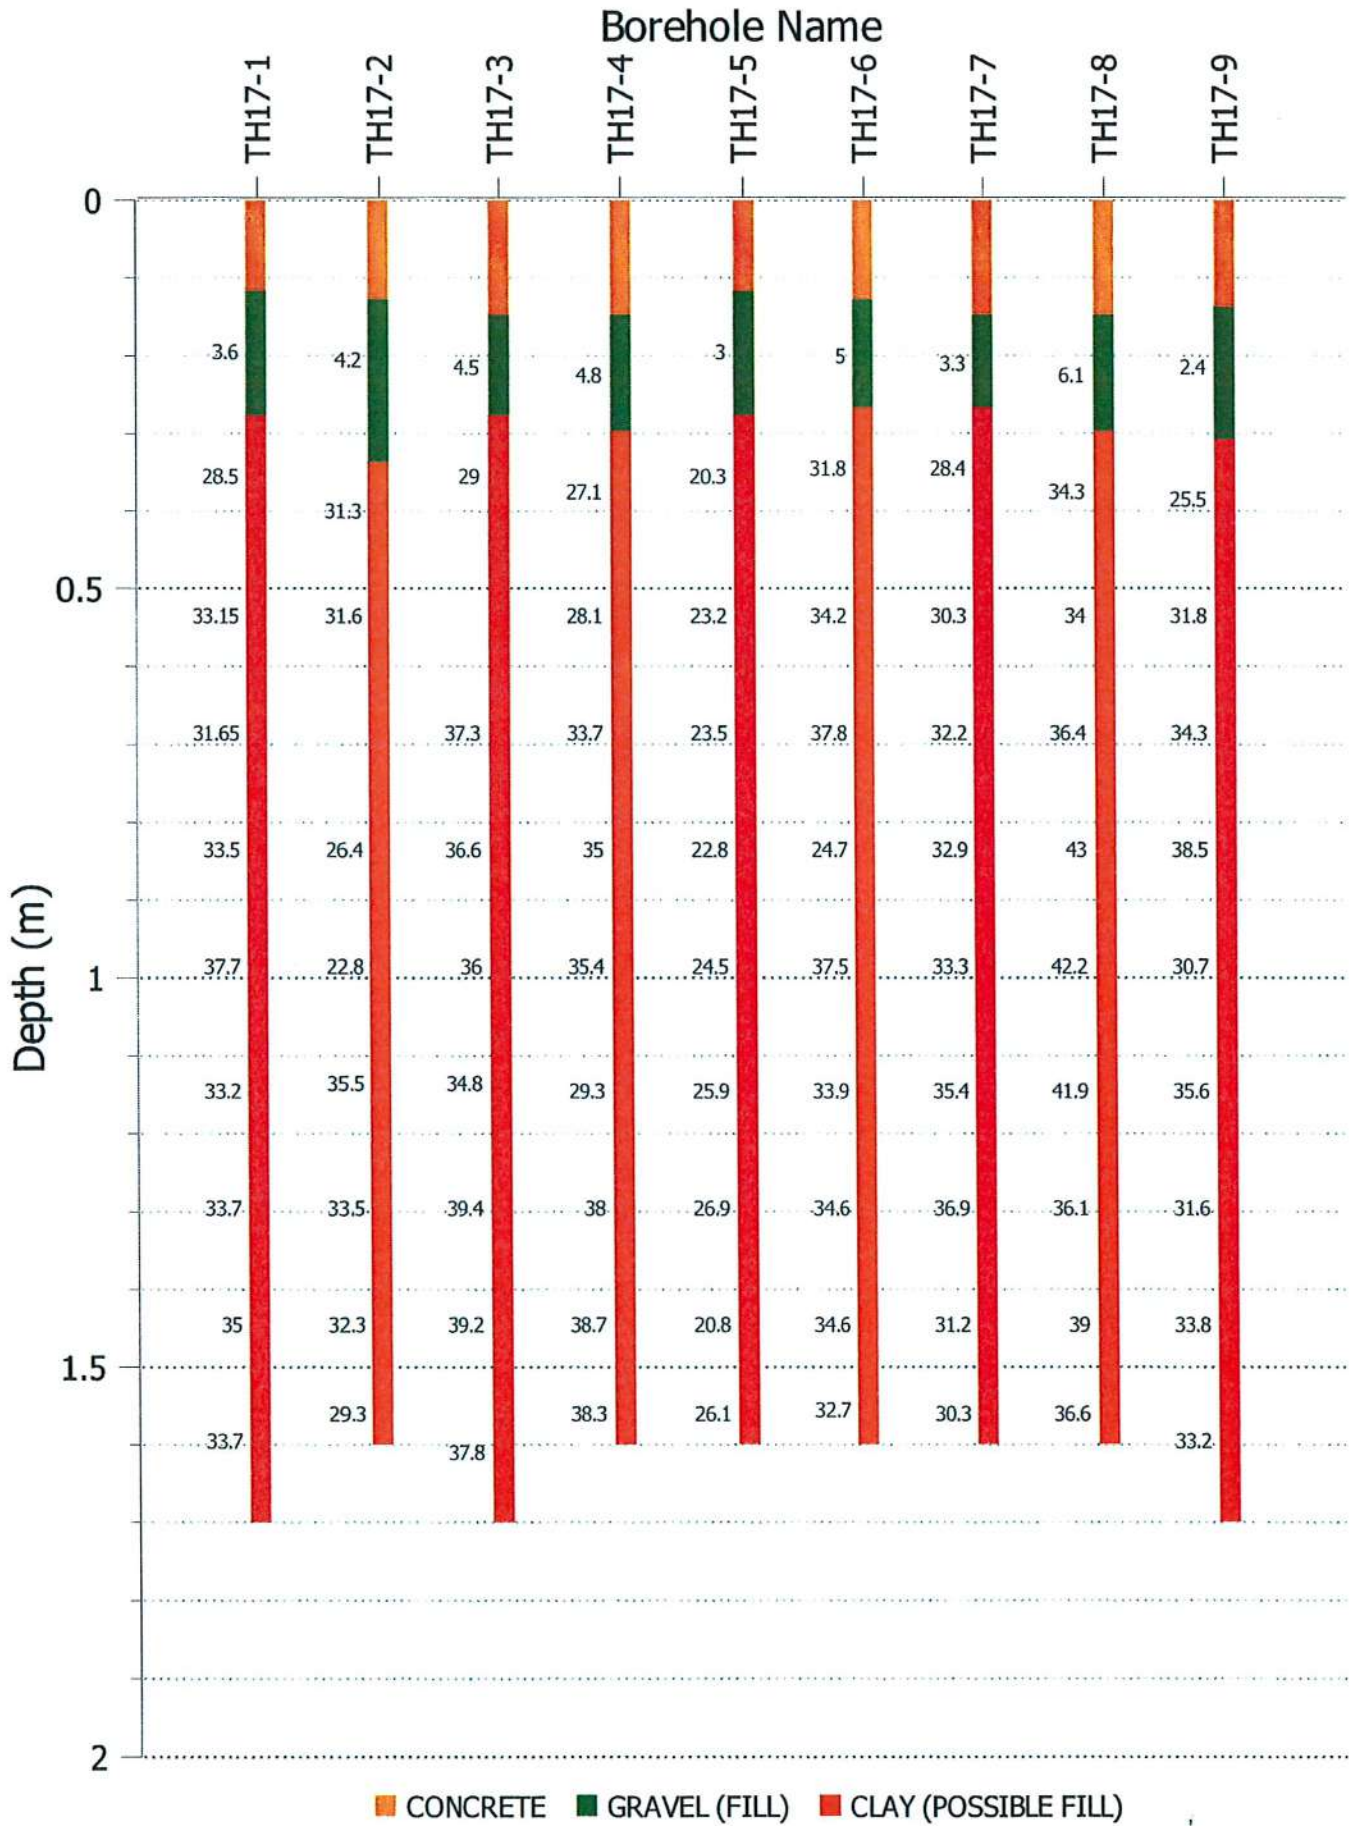
FIGURE 5.1
THURBER PROJECT # 20454

The water content in the clay ranged from 20 percent to 43 percent. A stratigraphic cross-section showing the observed stratigraphy and moisture contents in the bore holes is presented in Figure 5.1. A summary of moisture contents versus depth for all bore holes is presented in Figures 5.2 and 5.3, in Appendix A.

It can be seen that the moisture contents of the clay varies considerably between the bore holes. For example, in TH17-5 the moisture content ranges from 20 percent at the top of the clay to 27 percent below about 1.2 m depth. Whereas, in TH17-8, the moisture content ranges from 34 percent near surface to 43 percent at a depth of 0.8 m. The majority of bore holes, however, had moisture contents ranging from about 27 to 35 percent near surface, increasing to about 33 to 38 percent at a depth of one metre and staying relatively consistent below that depth to the bottom of the holes.

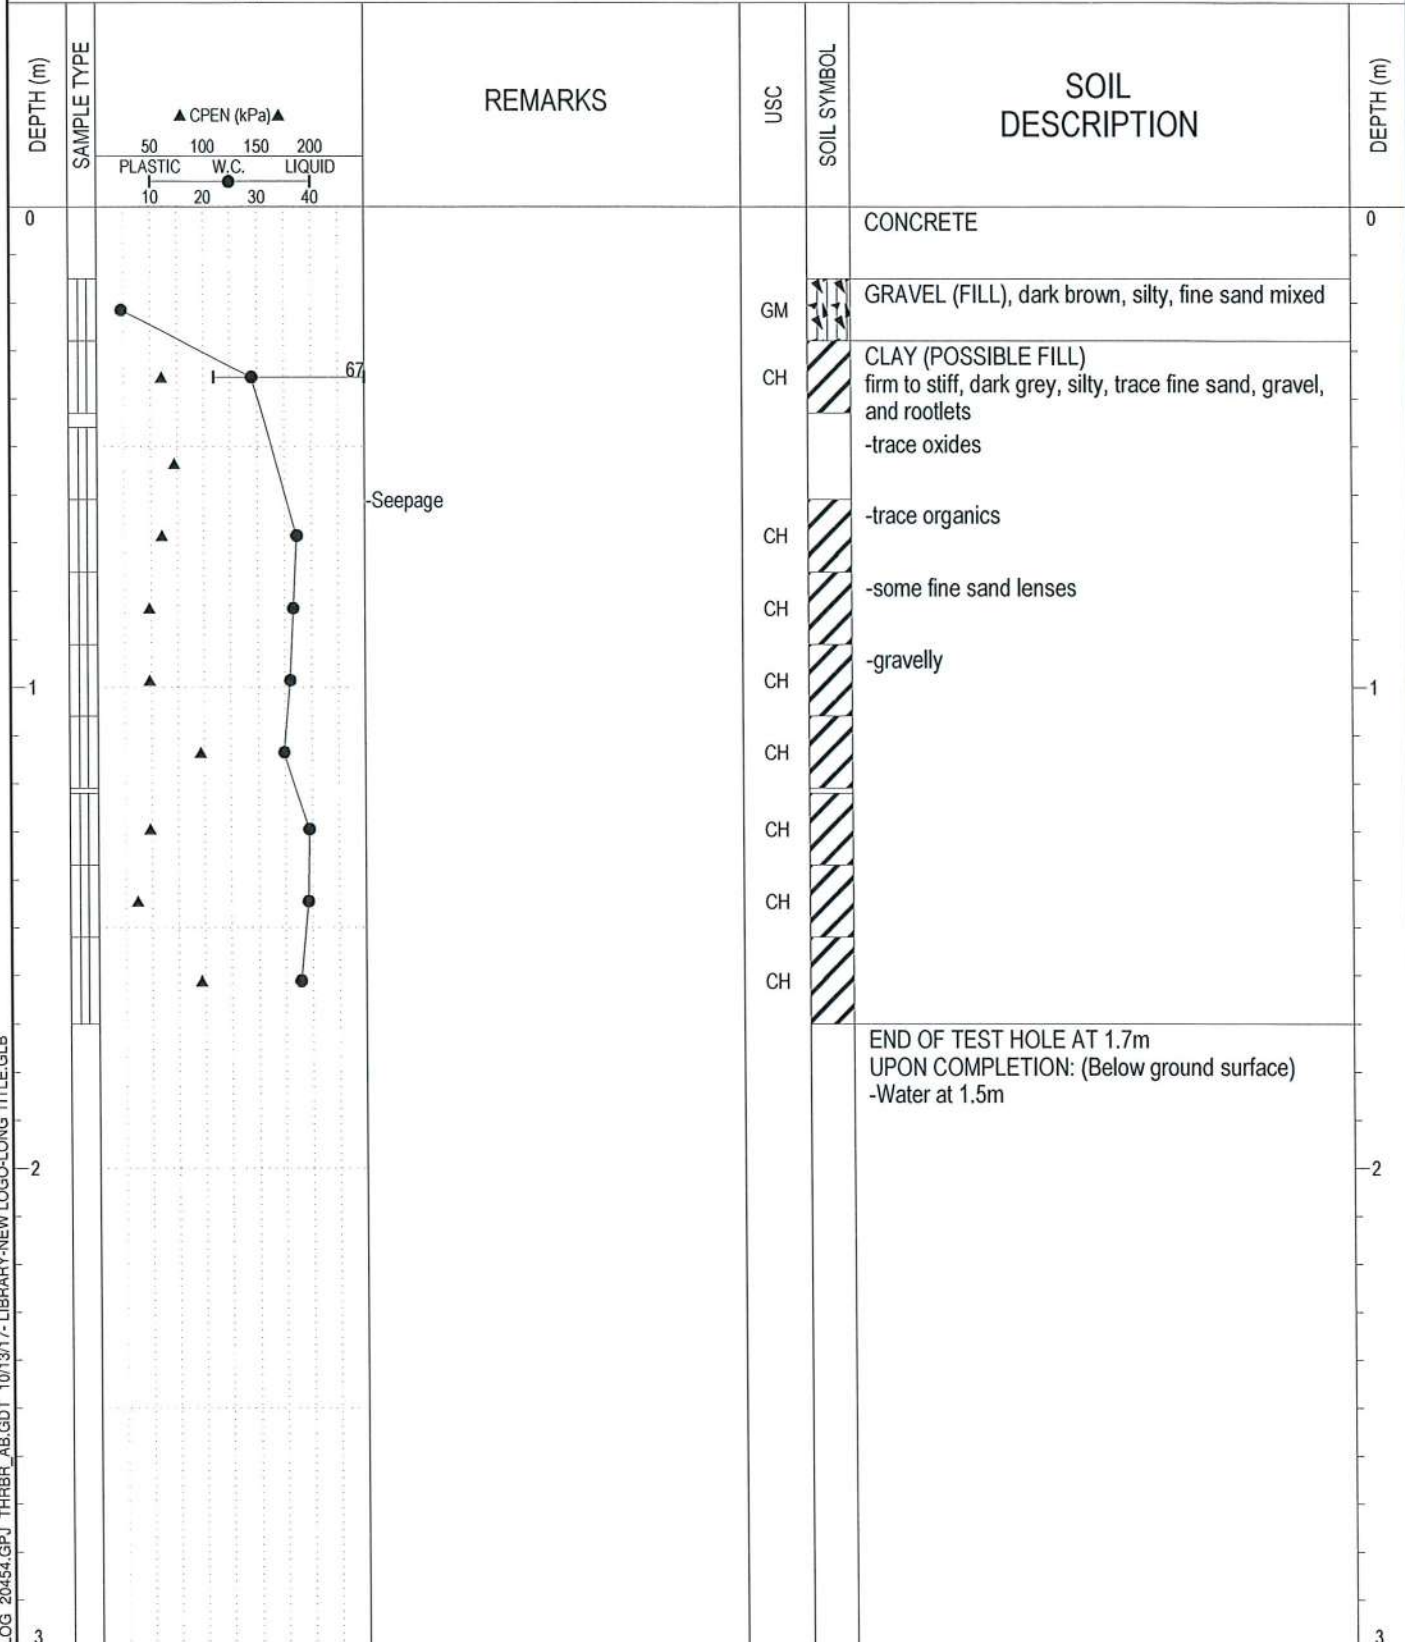
3. The majority of holes were dry at the end of drilling. Minor accumulation of groundwater seepage (i.e. was noted in TH 17-3, where seepage was noted from the clay layer at a depth of about 0.6 m below top of slab.
